Penetrating arterial trauma

Hassan Badri

Colin Nice

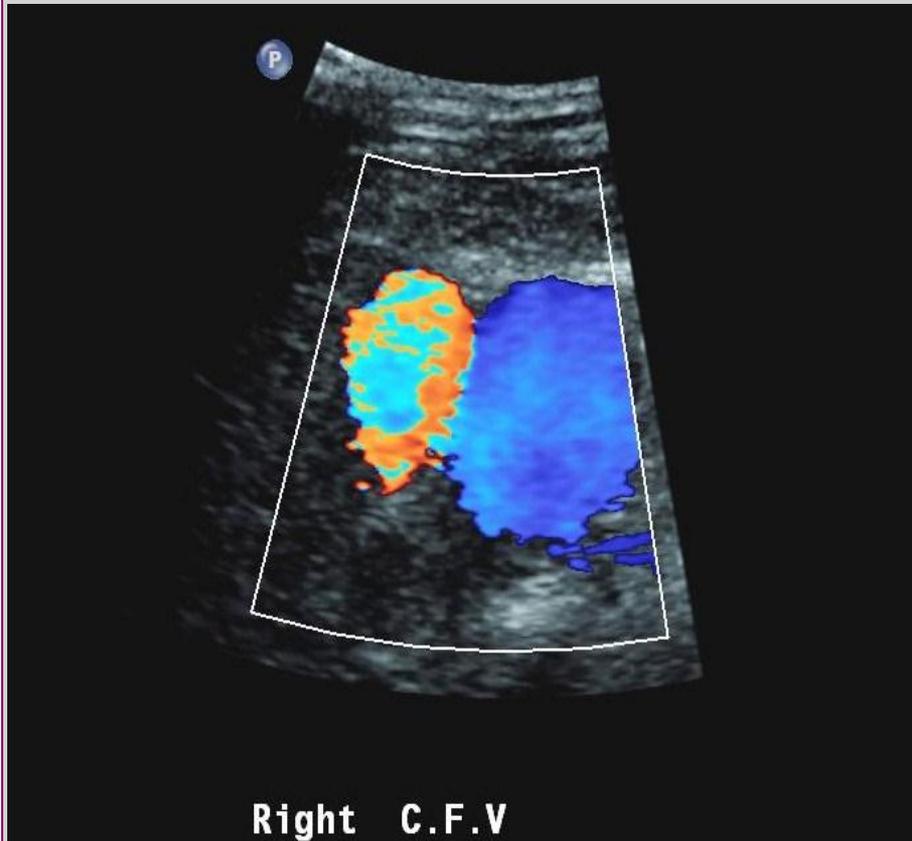
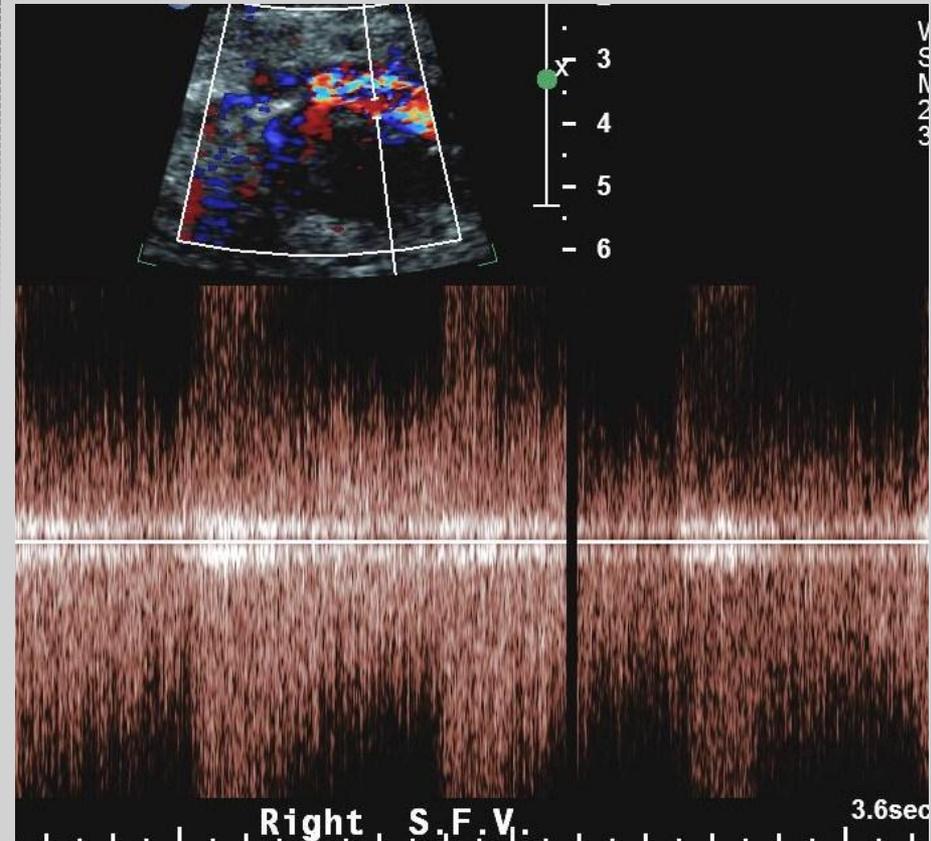
Duplex scan finding

- R. CFV distended + not easily compressible.

- Turbulent flow in the SFA +SFV

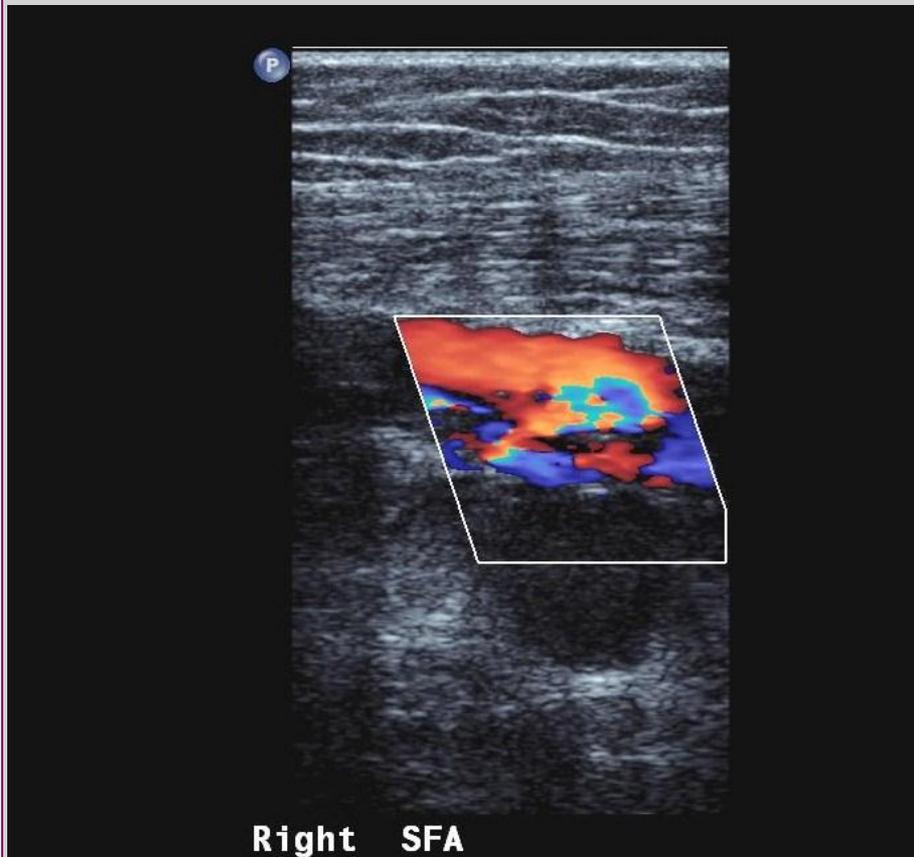
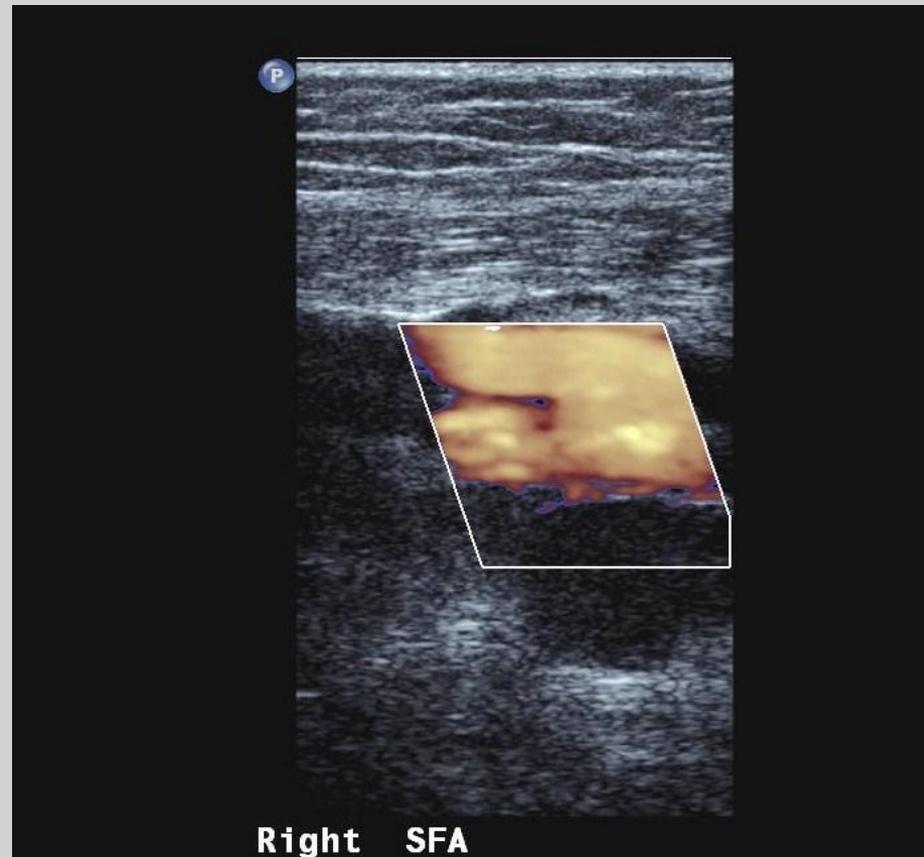
Duplex scan finding

Impression: traumatic R. AVF.

- Z shaped connection between the SFA +SFV

- Damped signal in distal R. Pop A

- Penetrating trauma sites of arterial injury may be distant to skin wounds
- Duplex ultrasound examination findings of a grossly distended non compressible vein with high velocity, low resistance, very turbulent flow are highly suspicious for AVF and are sufficient to plan endovascular treatment.

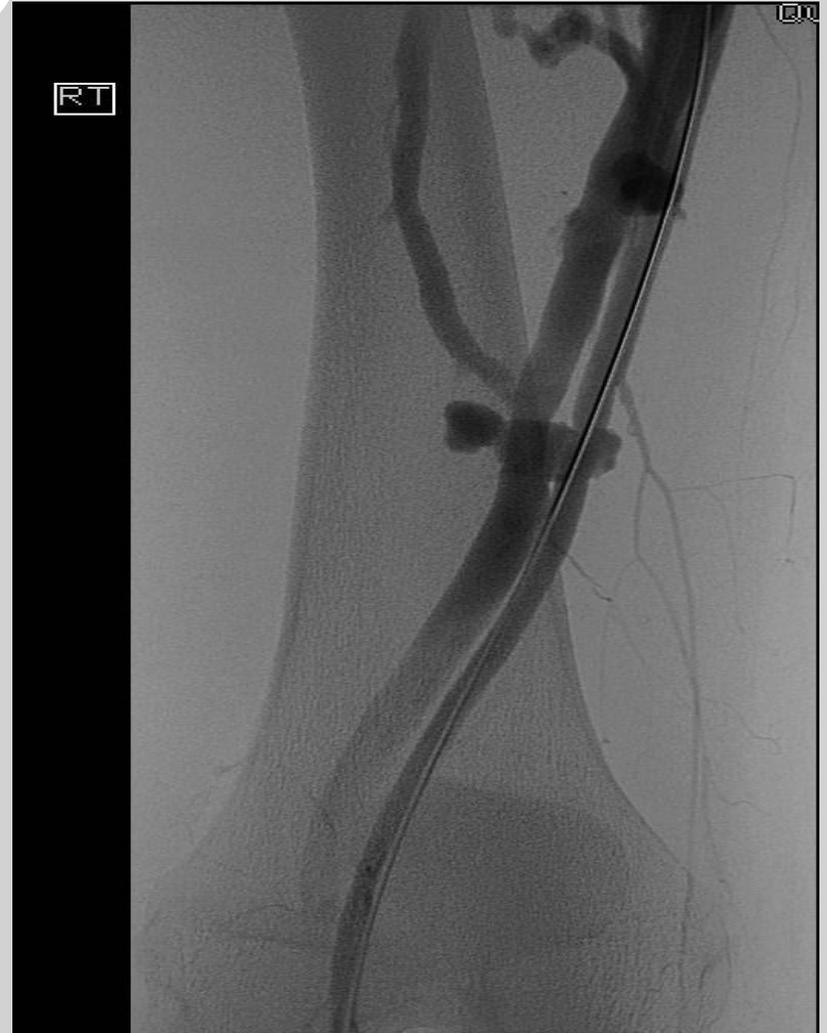
- Angiography
 - large defect within the distal SFA
 - High flow AVF
 - Rapid drainage up the SFV.
 - Moderate sized surrounding cavity (false aneurysm).

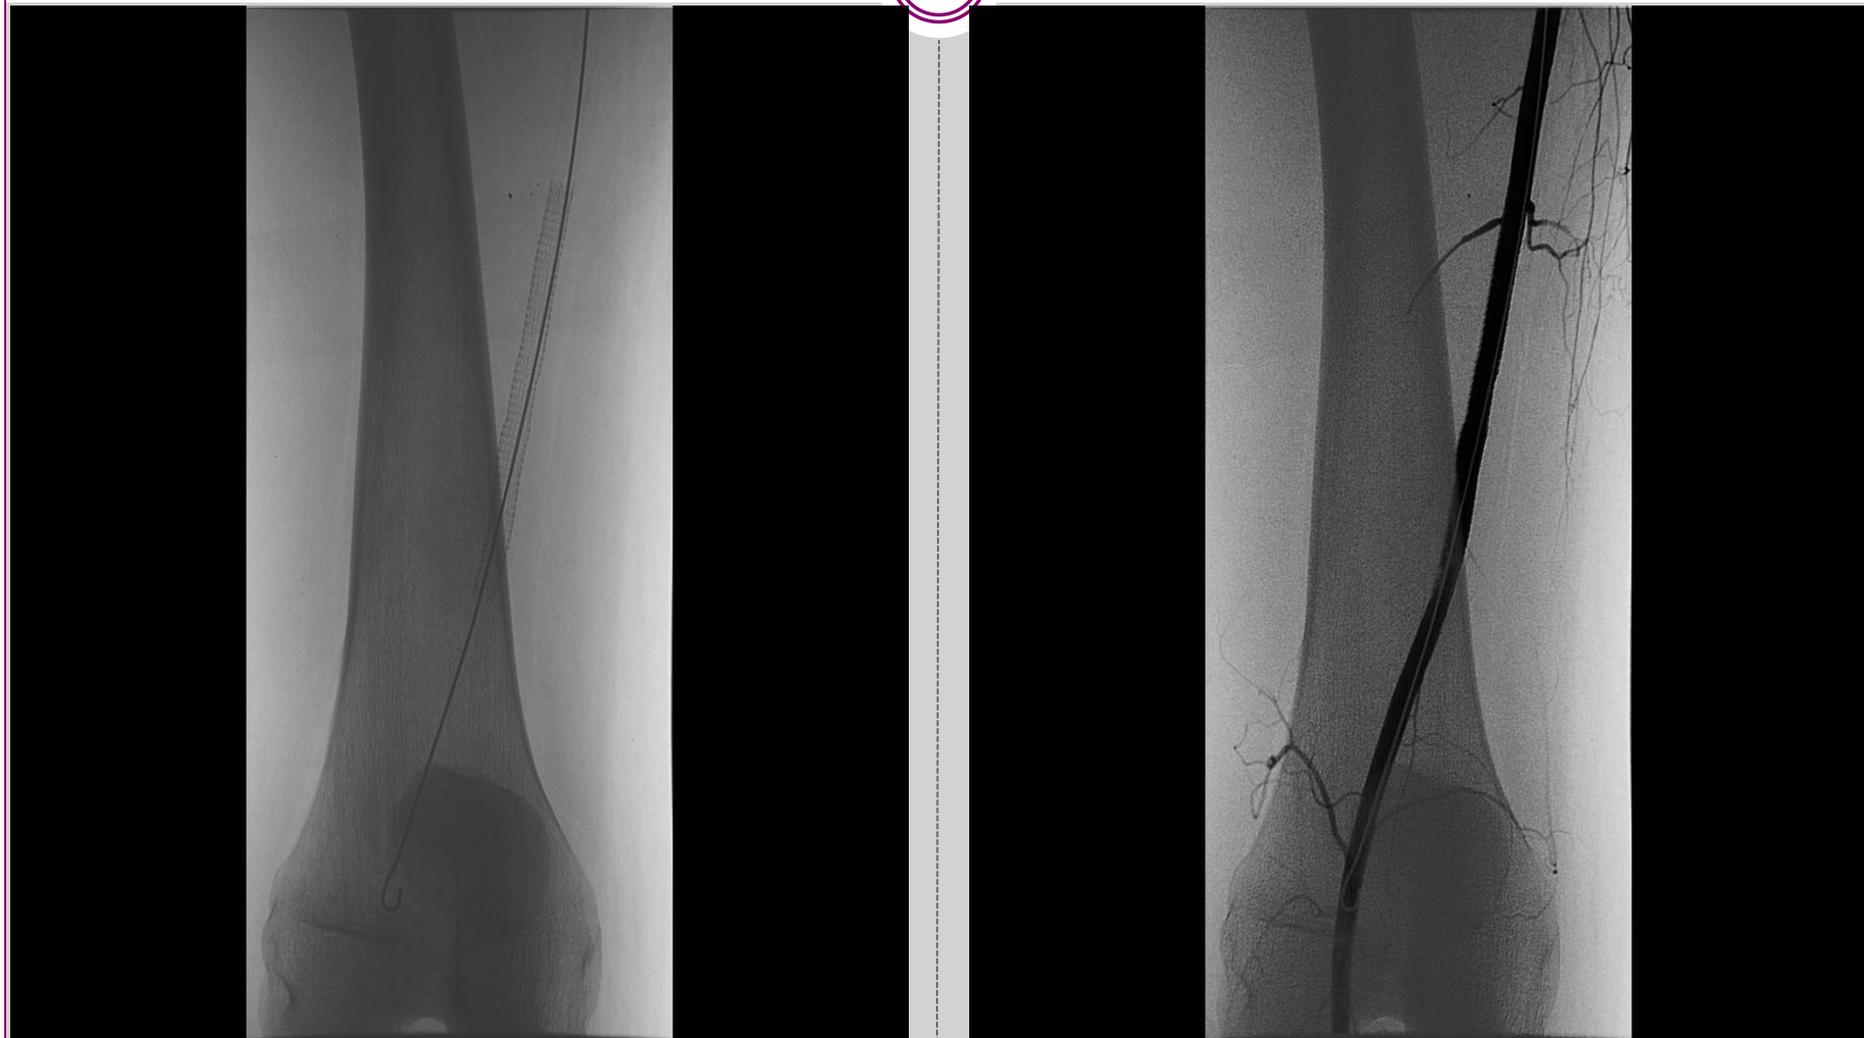
- arterial injury was crossed using a hydrophilic wire and cobra catheter.
- 7 mm wide, 10 cm long covered stent was placed in the arterial aspect of the fistula.
- Minimal distal overlap to avoid compromising future femoral- popliteal bypass in the event of stent occlusion.
